Heat Pumps, Mini-Splits & Air Conditioners - Commissioning with Smart Tools to Get It Right the First Time

Joe Medosch

measureQuick

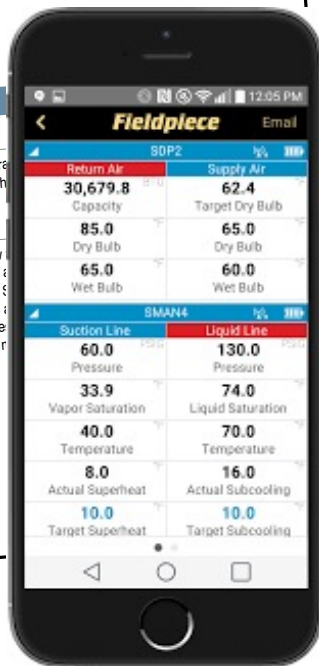
Job Link System Report

Split System - Heat Pump
Name **Rooftop 1**
Heat Type **N/A**
Heating Capacity **N/A**

AIR HANDLING UNIT
Carrier
Manufacturer **JSJSJDHHRHD**
Model **727737744**
Serial **TXV/EXV**
Metering Device
Target Superheat Table

DIAGNOSTICS

AIR FLOW
Supply Air Dry Bulb Temperature
Dry Bulb Temperature which evaporator coil.

CHARGE
Actual Subcooling is below undercharge. Confirm you refrigerant until the Actual After corrective measures as often as necessary to system to stabilize for 15 procedure.

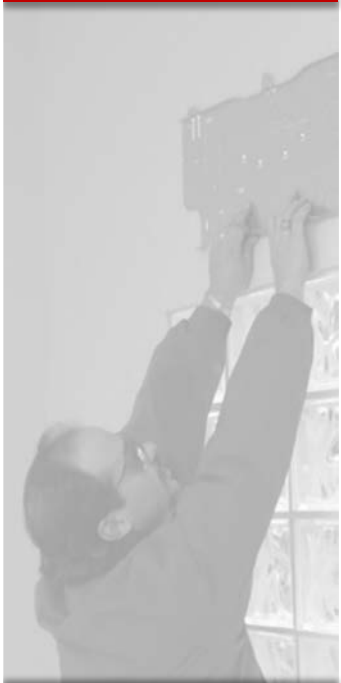
Step 1

Select Location

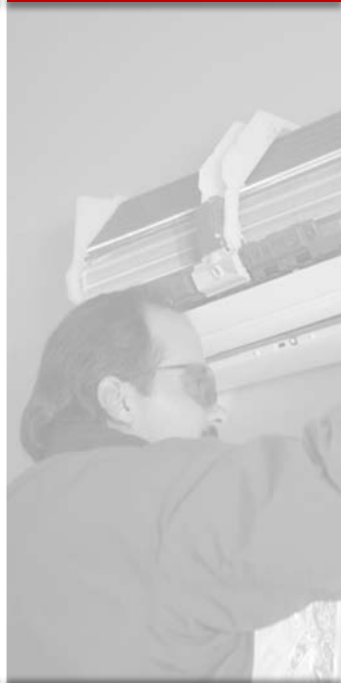
Step 2

**Install
Indoor Unit**

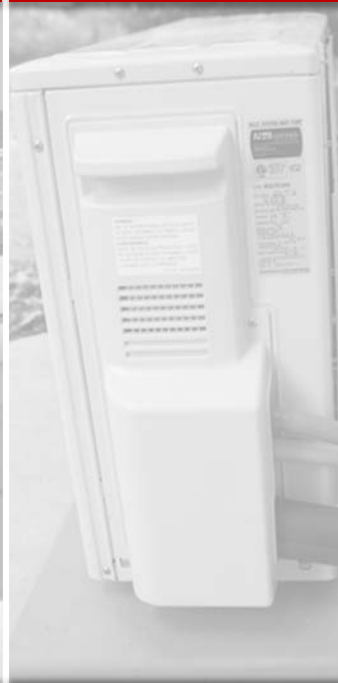
Step 3

**Install Outdoor
Unit**

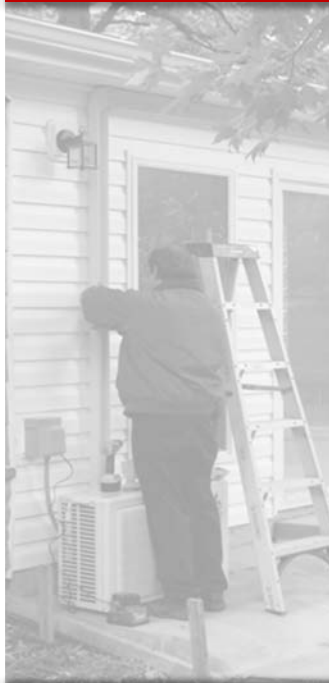
Step 4

**Interconnect
System**

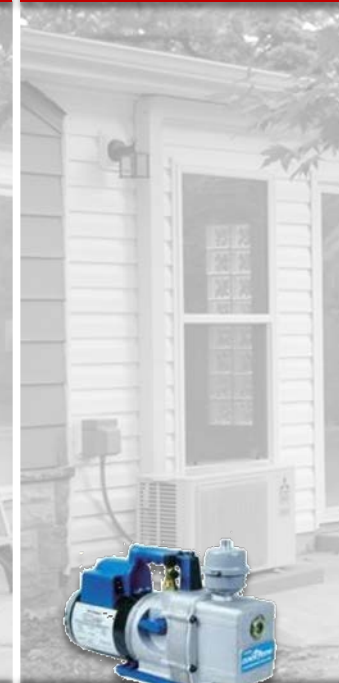
Step 5

**Leak Test and
Evacuate**

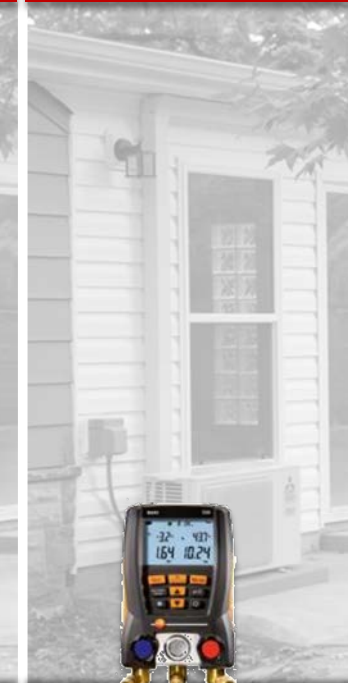
Step 6

Charge and Test

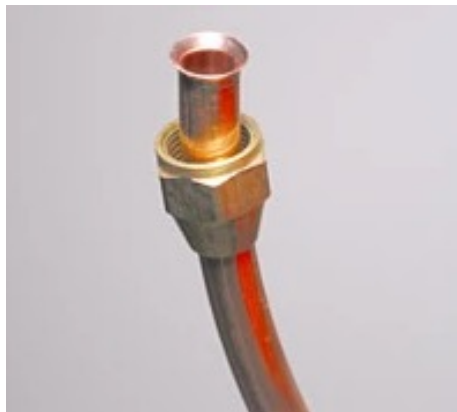
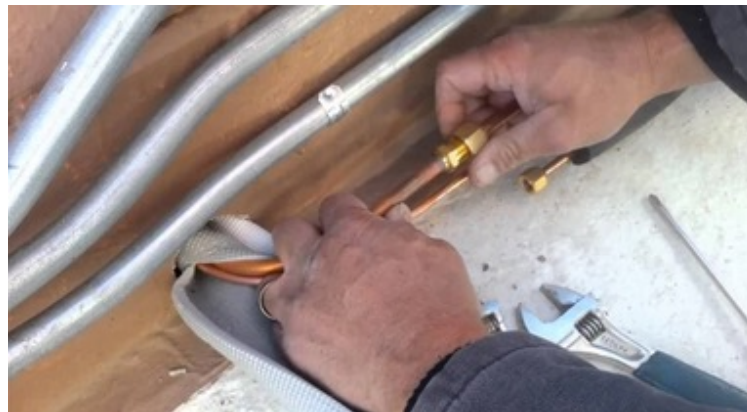
Flair connections are the #1 service issue

Tighten the flare nut with a torque wrench to specs.

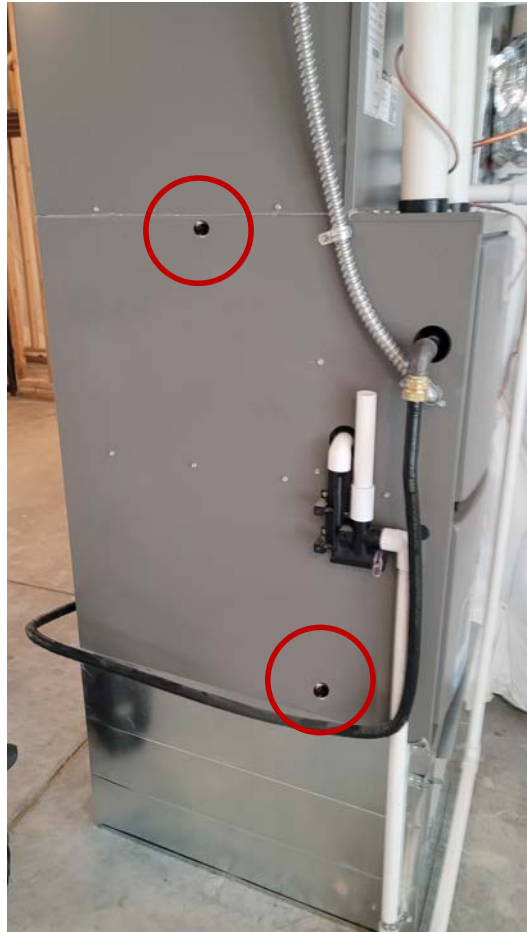
Did the Technician Measure for Static Pressure?

No holes in the air handler
= No static pressure
measurements

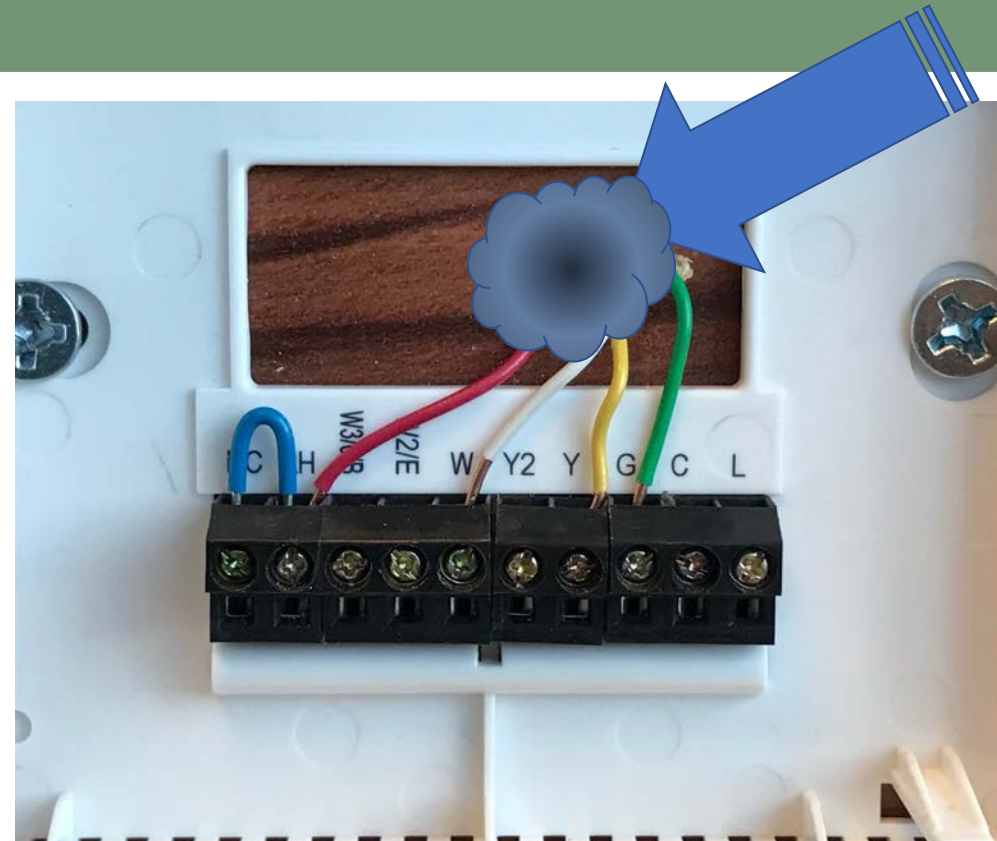
Poor Thermostat Installation

- Air leakage
 - Temperature swings
 - Excessive run times
 - Incorrect temperature and humidity readings
- **Plug with Thumb Gum**
- Not paper products!
